UNESCO ASIA-PACIFIC HERITAGE AWARDS
for Culture Heritage Conservation
2003 ENTRY FORM

Conservation of the Catholic Cathedral of the Immaculate Conception, HKSAR

16 Caine Road, Mid-Levels, Hong Kong Special Administrative Region, China

Date of Completion of the Project (must be post-October 1991) 8 December 2002

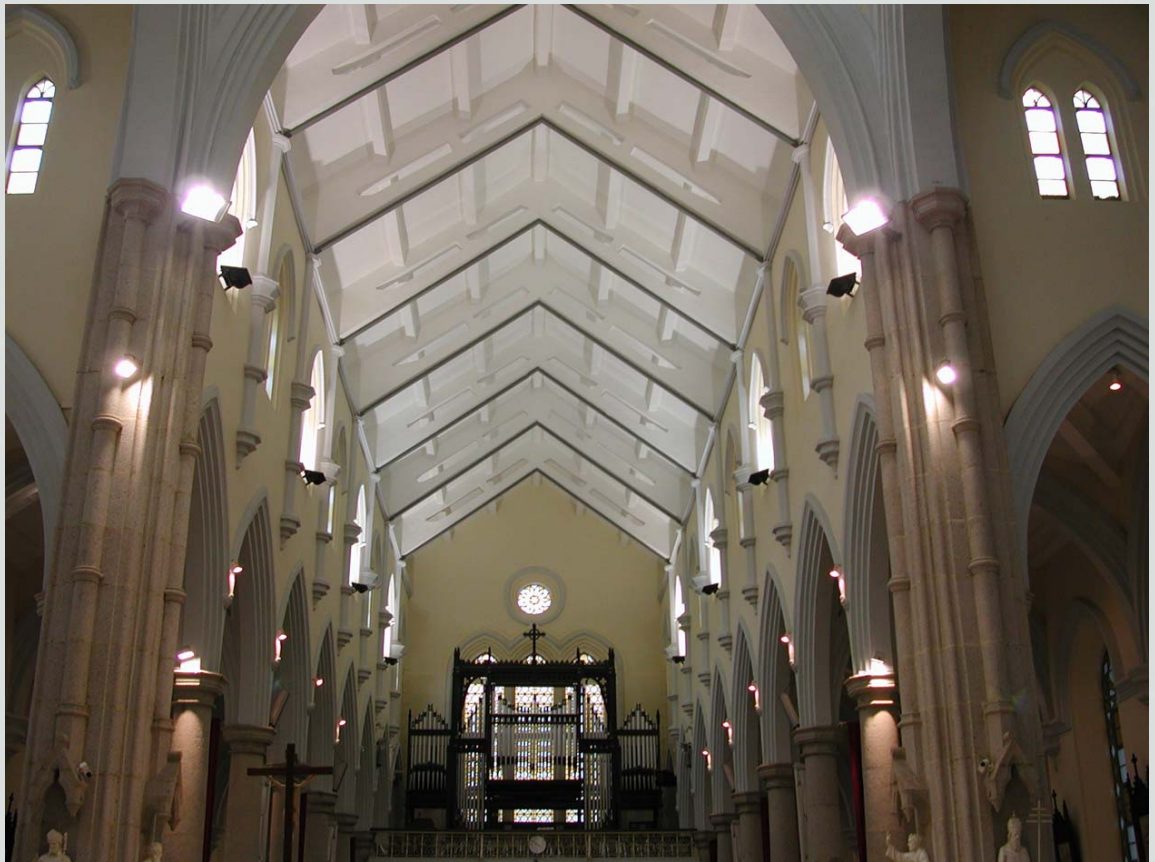
*Before - interior lighting
 only to meet functional
 illumination requirement*

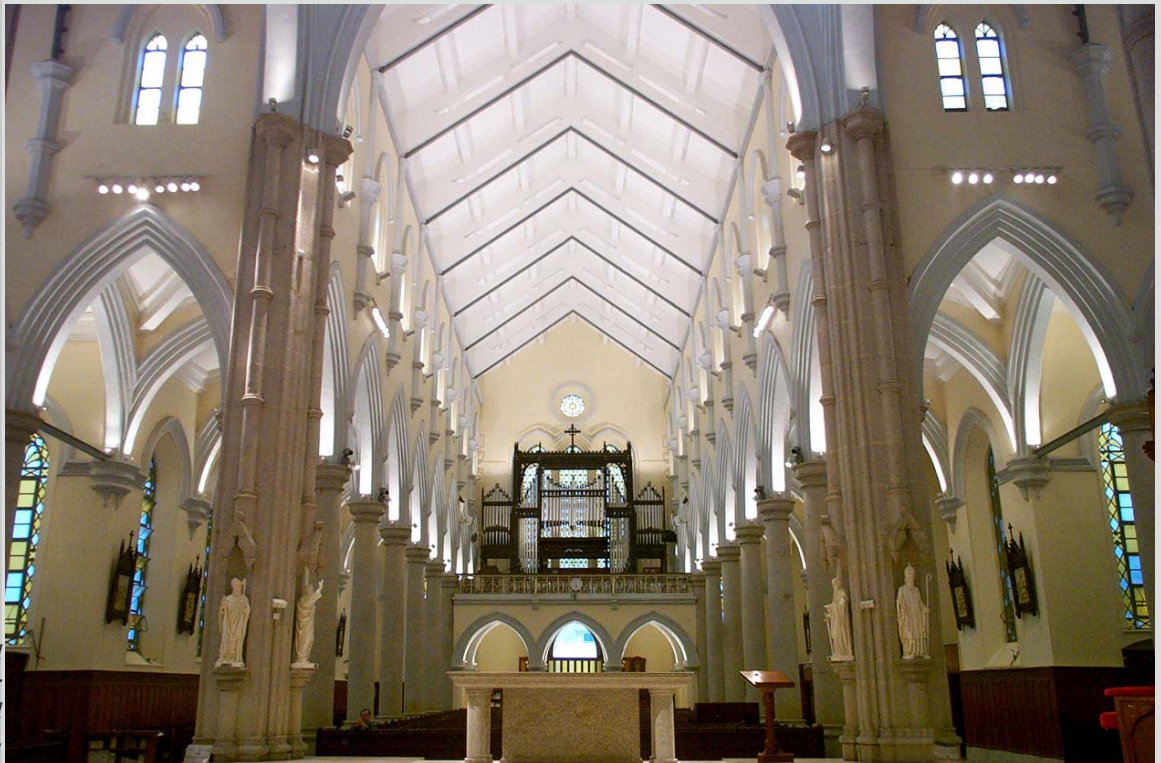
*After - enhanced
 ambience for
 liturgical prayers and
 ceremonies*

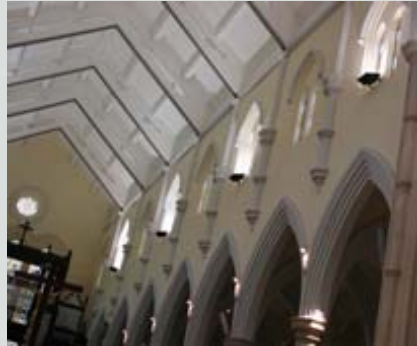
Before - view 1

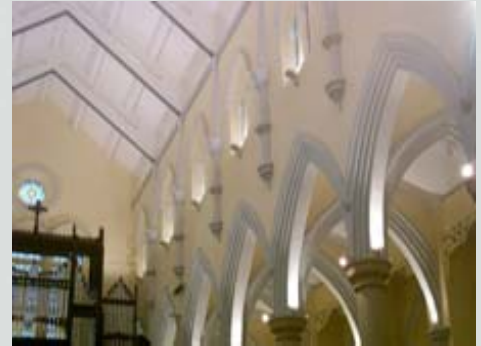
After - view 1

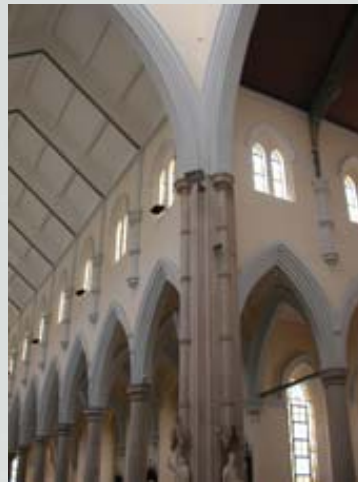
Before - view 2

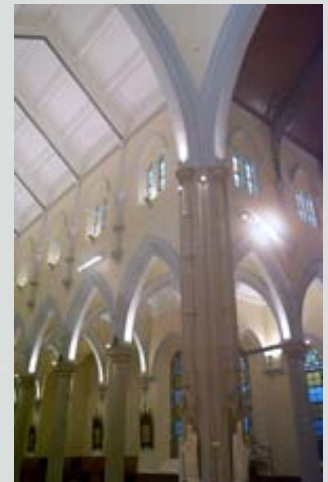
After - view 2

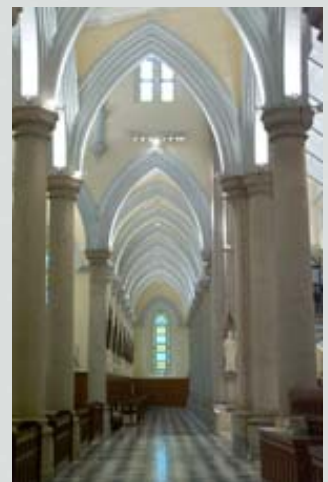
After - view 3

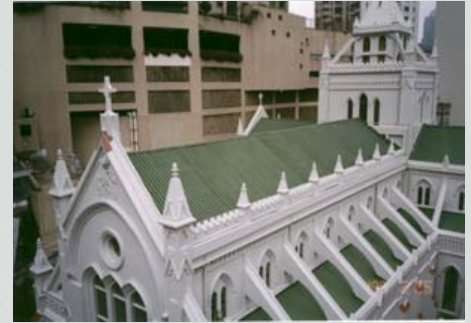
Before

*Series of
 comparison
 photos for
 waterproofing
 and external
 paint works*

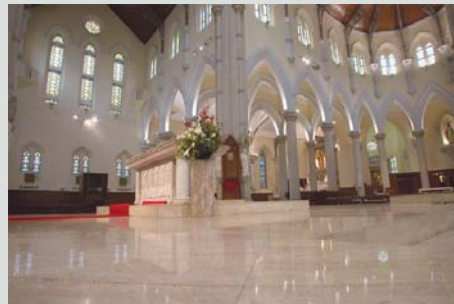
View - Main altar after completion of the conservation project.

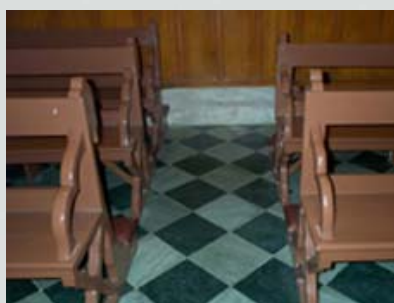
Completed photo record

The Buildings Department had served a Dangerous Slope Order in 1998 for the slope of Caritas building adjoining the Cathedral, the ground settlement has led to the subsidence of floor at St. Joseph altar and the cracking of marble flooring. During the slope stabilization process, an old air-raid shelter was accidentally found which was left in-situ for future study.

During the repair of the internal marble flooring, salvaged floor tiles were used to match the existing flooring pattern. Where salvage tiles were insufficient to cover the floor paving at the St. Joseph altar, new marble tiles of matching colour to the oldest surviving flooring were laid to harmonize with the floor pattern.

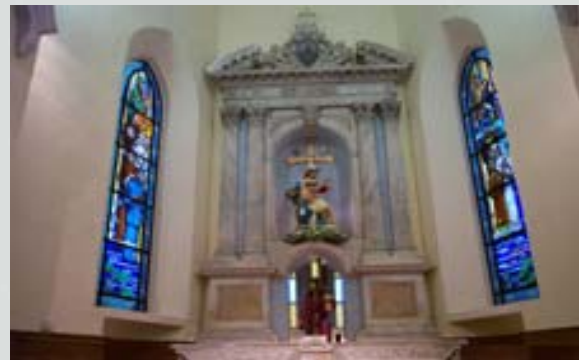
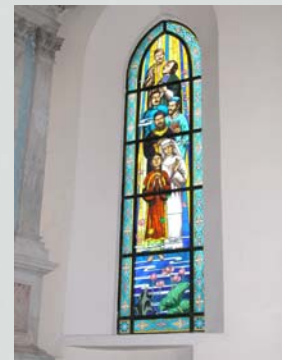
Newly completed stained glass at the Chapel of Our Lord's Passion for the Chinese Martyrs

A Chinese artists, Mr. Zhang Qi-kai was commissioned to replace the existing geometric patterned stained glass windows with a theme based on the Chinese martyrs. The stained glass was produced in Zhang's studio in Milan, Italy. The stained glass, which was fired to 800° C, was supplied from Italy, France and Germany. Traditional techniques and craftsmanship were used to convey the meaning of the Chinese martyrs.

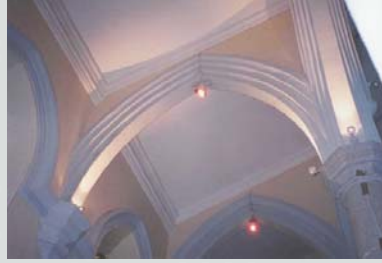
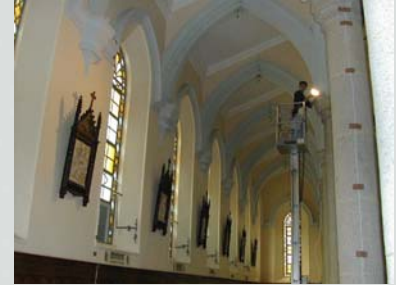
Mock-up inspection for interior lighting prior to selection of supplier's proposal

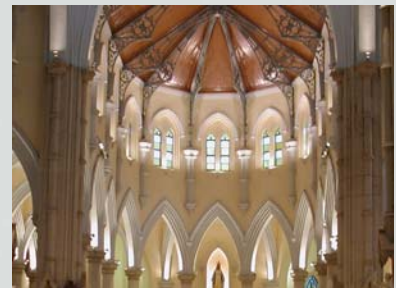
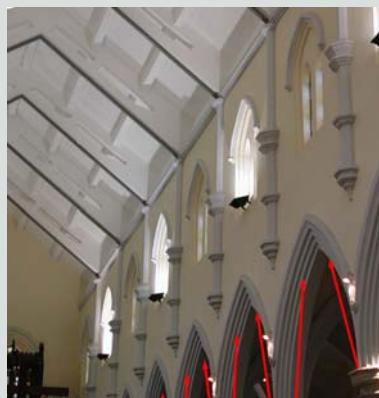
Comparison of design intent diagram and actual completed lighting effect

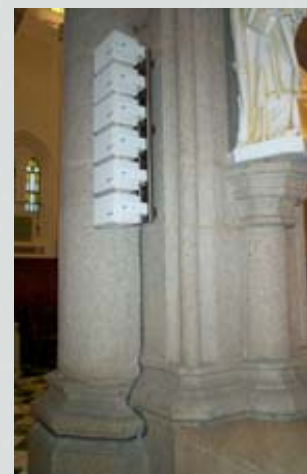
Concept of the stainless steel speaker support is to imitate the pipe organ of the Cathedral. With the protruded pipes being cut short after mock-up inspection to make it less obtrusive

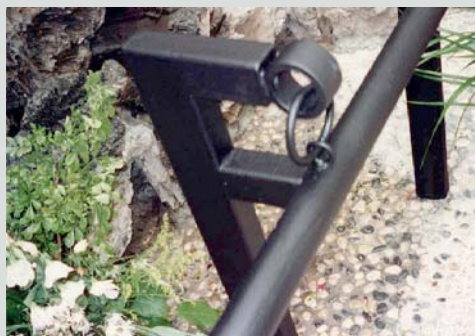
Close up view of handrail design detail

The railing previously installed for the convenience of the parishioners praying in front of the grotto was considered to be incompatible. To improve the situation, a raised platform of geometry to match the external architectural character of the Cathedral was designed and traditional granite paving was laid to provide a safe setting in front of the grotto.

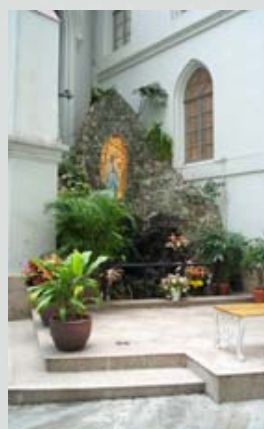
Raised platform to define space and
